CASE STUDY: Replacement AOV installations

Customer requirement

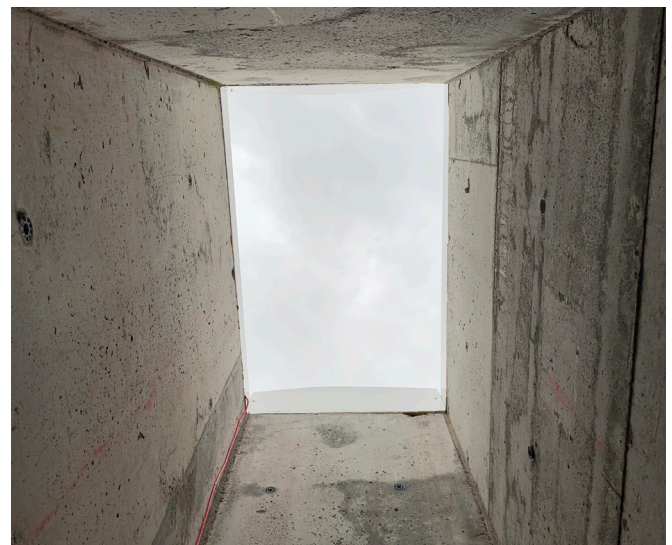
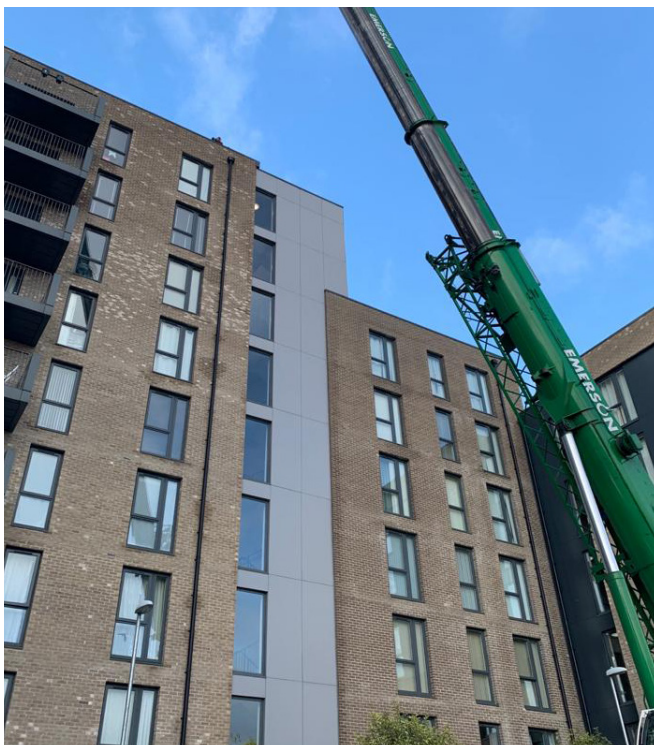
When carrying out an initial inspection, servicing and maintenance visit covering all fire safety systems and measures for 24 apartment blocks in London, the client made use aware of an issue with one block's natural smoke shaft.

Apparently, the original dome fitted to the shaft blew off in a storm!

A replacement louvre vent (which is the correct vent to have in this case) had been sat in a storeroom for several months on site awaiting installation.

We contacted the manufacturers Xtralite to confirm the vents specification who were exceptionally helpful. Due to the time that had passed in supplying the vent and the potential damage and weathering to the shaft we agreed that it would be best for an installation team from Xtralite to be assisted by RES engineers.

The replacement louvre vent was successfully lifted into place by a local crane hire company.

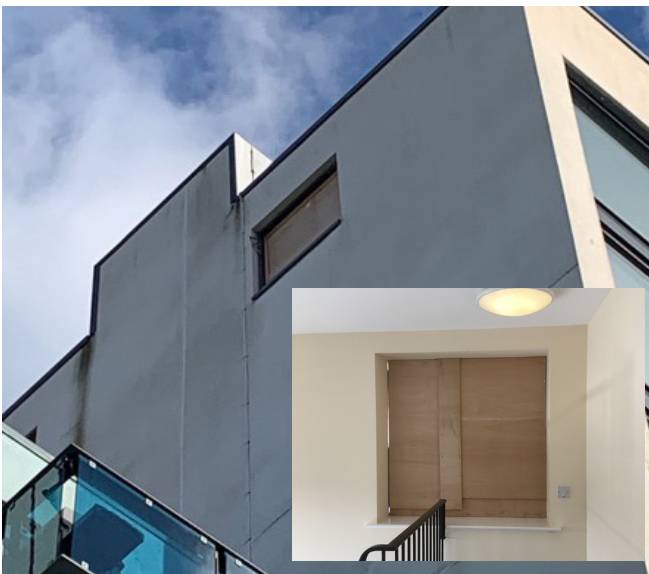
While the crane was on site, during our initial inspection, servicing and maintenance visit our engineers had reported damage to the block's stairwells AOV dome so this was replaced at the same time as the smoke shafts louvre vent.

With the crane, Xtralite and RES engineers already on site, the damaged dome was very economical to replace.

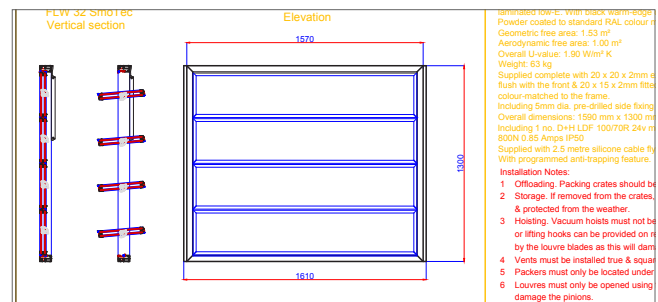
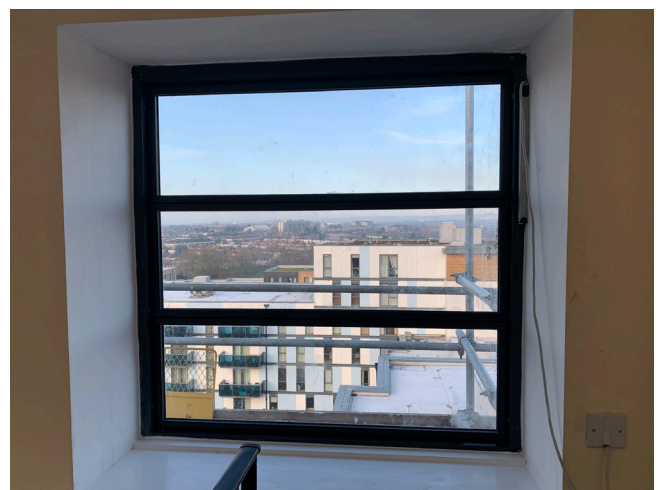
Louvre window

We again came across this issue during our initial inspection, servicing, and maintenance visit. Straight away it was obvious looking at the buckled window that it should never have been installed.

The reason behind it was that the roof opening for a dome (which you expect to find at the top of a stairwell core) was just the other side of the stairwell cores wall so it must have been put in the wrong place from construction as the lobby to the apartments had an AOV the same as all 8 floors below.
