Initial inspection

New FD30 Fire Door

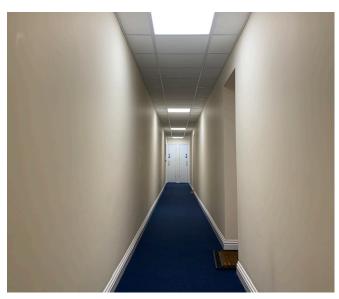
When carrying out an initial inspection, servicing and maintenance visit covering all fire safety systems and measures for 24 apartment blocks in London, we made the client aware of an issue with a corridor in one of the blocks.

All six floors above had a cross corridor fire door halfway along a long corridor connecting two stairwell cores. Not an issue regarding travel distance under Building Regulations but there were two separate smoke control systems at each end of the corridors, one natural and one mechanical.

So - quite important that a dividing fire door was in place!

Its important to have a premises fire strategy drawing and document, and in this instance on being provided the information by the client the door was in fact missing from the drawings.

So this is how the situation had remained for 9 years until our initial take over service.

A site meeting with a local Fire Safety Inspecting Officer confirmed our findings and advice so a new FD30s door set was quickly ordered and installed by our Passive Fire engineers.

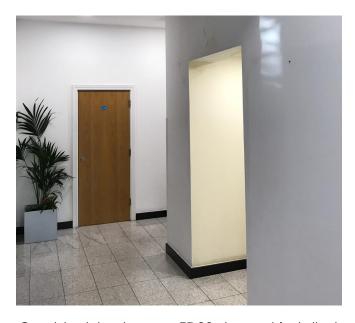
After a Fire Safety Inspecting Officers visit to two residential blocks in Canary Wharf, London we were contacted by the officer to discuss missing lobby doors.

Both blocks had been like it for 7 years since construction so with no confirmation being available why two blocks out of 7 did not have ground floor lobby doors, we agreed with the client to install them.

One block had a new FD30 door set installed to match the existing doors by our engineers.
