Initial inspection

New FD30 Fire Door

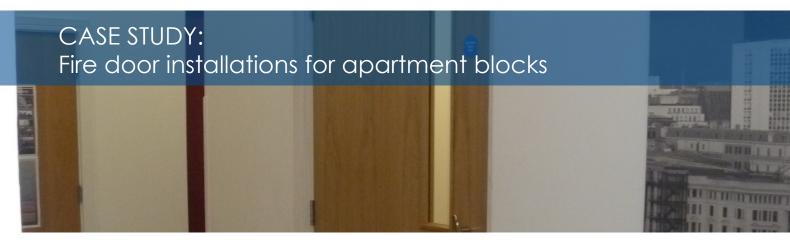
When carrying out an initial inspection, servicing and maintenance visit covering all fire safety systems and measures for 24 apartment blocks in London, we made the client aware of an issue with a corridor in one of the blocks.

All six floors above had a cross corridor fire door halfway along a long corridor connecting two stairwell cores. Not an issue regarding travel distance under Building Regulations but there were two separate smoke control systems at each end of the corridors, one natural and one mechanical.

Its important to have a premises fire strategy drawing and document, and in this instance on being provided the information by the client the door was in fact missing from the drawings.

So this is how the situation had remained for 9 years until our initial take over service.

A site meeting with a local Fire Safety Inspecting Officer confirmed our findings and advice so a new FD30s door set was quickly ordered and installed by our Passive Fire engineers.
